Appendix F
White Paper: Effects of
Asphalt on EM-62-MK2

Effect of Asphalt on EM61-MK2 Response to Subsurface Metallic Items

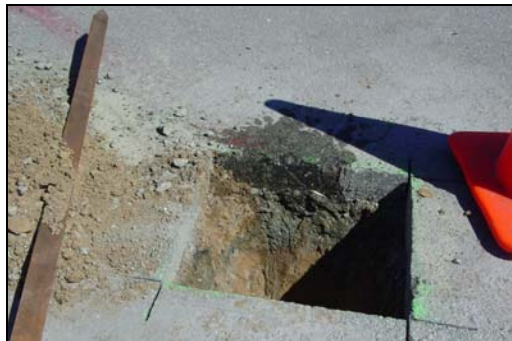
Photograph 1—Approximately 14-in.-squares were cut into the asphalt so test items could be buried underneath it.

To place the test items under the asphalt surface, square holes, approximately 14 in. on a side, were cut into the asphalt. Prior to collecting data, the asphalt pieces were removed from the ground, the test items were buried, and the asphalt pieces were placed back over the ground.

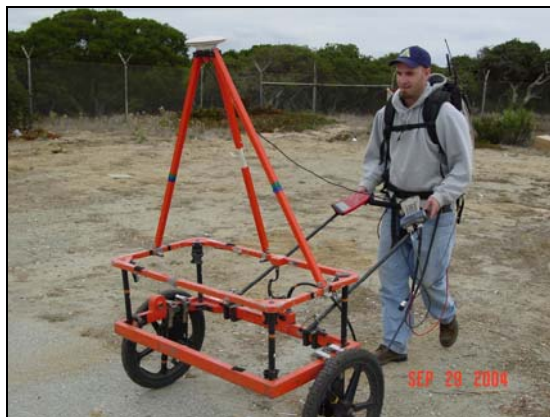
6
7 Photograph 2—Three sets of geophysical data were collected with the EM61-MK2 system pictured.

1 An EM61-MK2 cart was pushed over the test grid to collect three sets of geophysical data
2 (Photograph 2). The first data set was collected with no test items seeded, which was the control
3 data set; the second set was collected with the test items buried 12 in. below ground surface (bgs
4 [bgs is measured from the top of the item to the ground surface]); and the third set was collected
5 with the test items buried 18 in. bgs.
